# A Prognostic Development Methodology with Demonstration Examples

**DARPA/DSO Prognosis Bidder's Conference**  
**September 26-27, 2002**  
**Alexandria, VA**

**Bill Hardman**  
**[hardmanwj@navair.navy.mil](mailto:hardmanwj@navair.navy.mil)**  
**Propulsion and Power**  
**Naval Air Systems Command**

# Intermediate Gearbox Pinion Crack Test

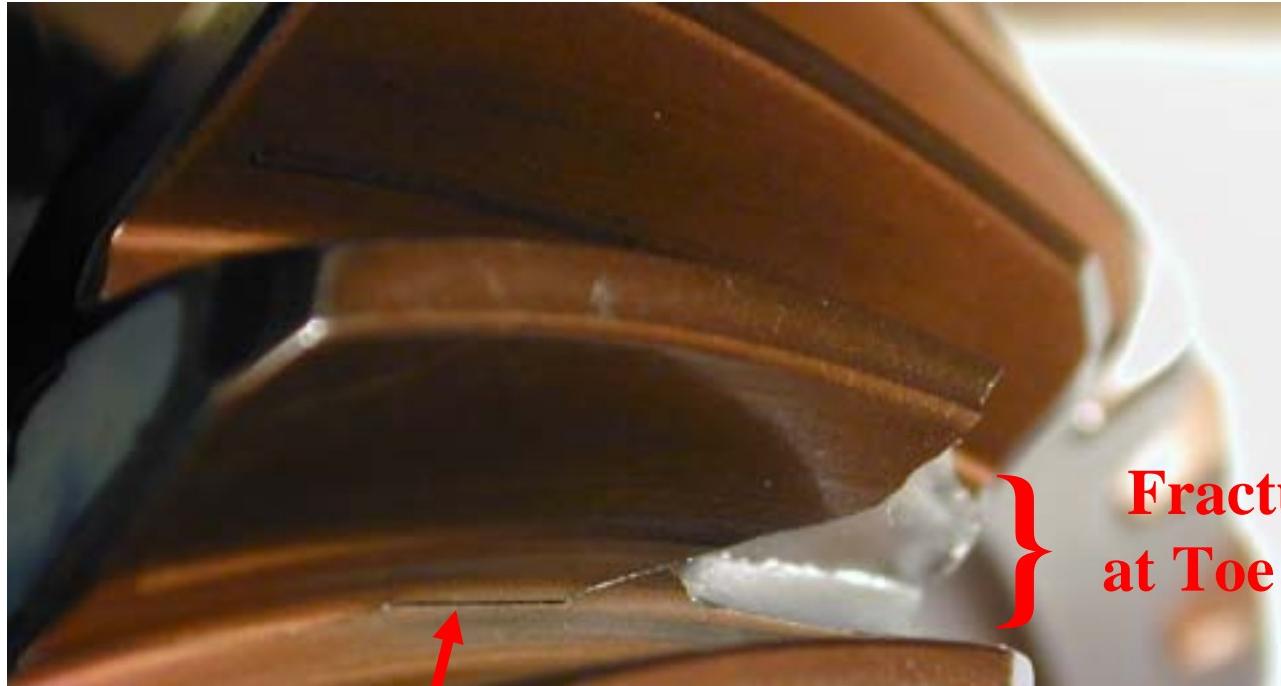
EDM Notch (0.25" L x 0.04" D x 0.005" W)

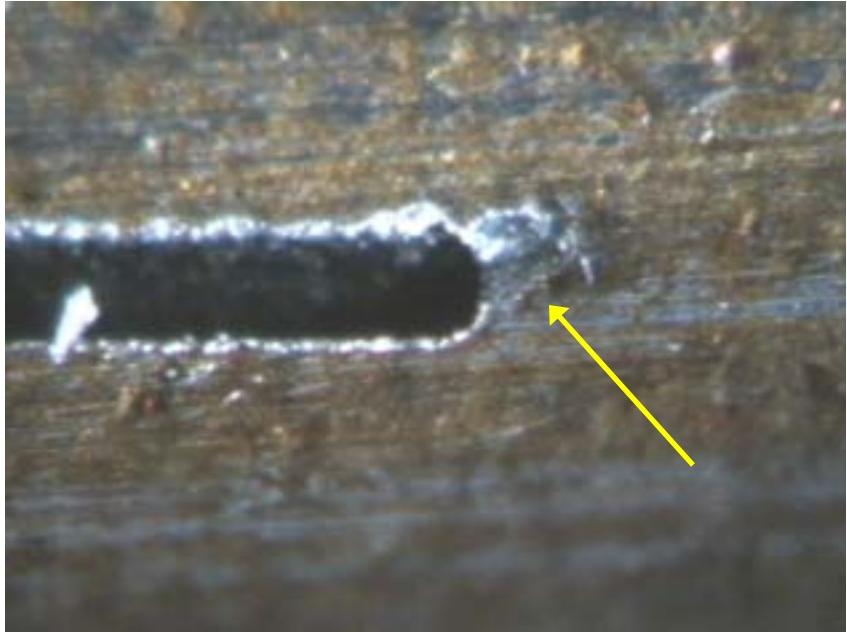
Image of heel notch inner end after Run 15 (first test), showing small chip liberated (arrow). No noticeable change until run 18.

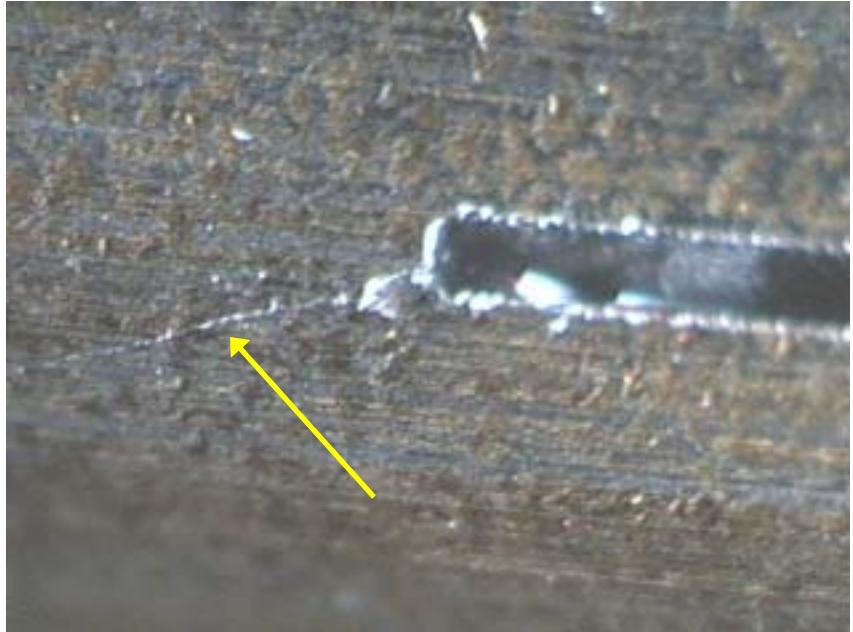
Image of heel notch outer end after Run 18 (first test), showing obviously visible crack (arrow).
